# Coes Reservoir

## 2022 Water Quality Report

Brought to you by  
The City of Worcester Lakes and Ponds Program

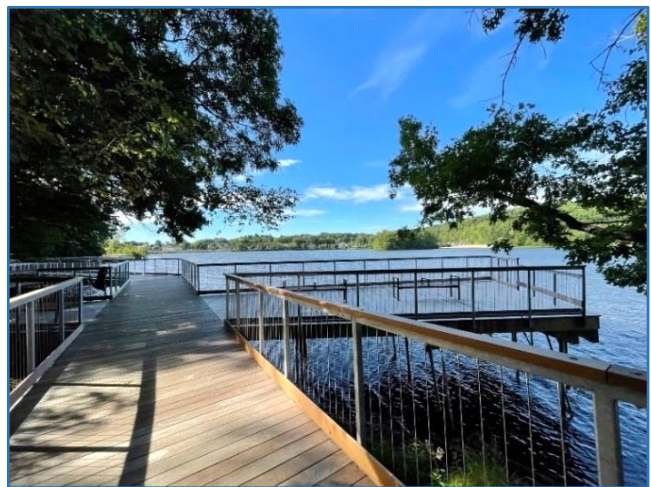
*Figure 1 – A newly constructed boardwalk provides universal access to the Eastern shore of Coes Reservoir.*

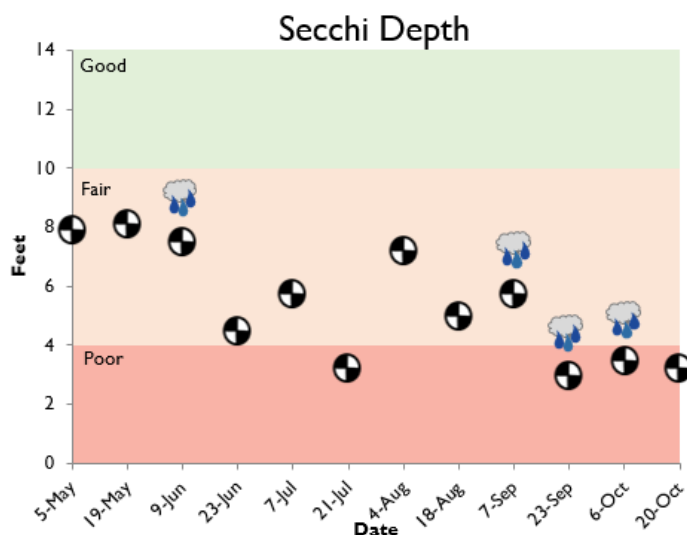
**Figure 3** - Secchi depth ranged from the "Poor" to "Fair" categories throughout the season. "Poor" secchi depth was seen generally later in the season.

**Water Clarity at Coes Reservoir.** Secchi clarity at the two in-lake sites in Coes Reservoir ranged between 8.50 ft and 2.75 feet (see *Figure 3*). Most readings fell between 4 and 10 ft, or in the range considered “Fair” although several results were lower, especially at the end of the season when the waterbody was experiencing a cyanobacteria bloom. Surface TSS at Coes Reservoir ranged between 3 and 11 mg/l, with most results falling below 10 mg/l, or in the range considered “Excellent”. Results at the bottom of the reservoir ranged between 3 and 14 mg/l, and were generally lower than 10 mg/l. Maximum TSS readings were all recorded on 23-Sep, when the lake was experiencing cyanobacteria bloom conditions. Overall, water clarity was considered “Fair” at Coes Reservoir in 2022.

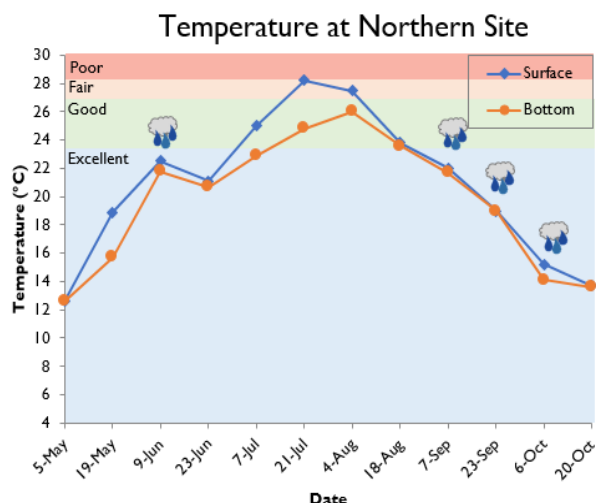
**Figure 4** - Bottom temperatures were considered "Excellent" all season. Surface temperatures were in the "Good" to "Excellent" categories except for two dates that were considered "Fair".

**Temperature at Coes Reservoir.** Surface water temperature at the in-lake sites began in the "Excellent" category at the beginning of the season and climbed to the maximum recorded temperature on 21-Jul before decreasing into the fall (see Figures 4 and 5). Maximum recorded surface temperatures in 2022 were considerably higher than in 2021, at 28.2°C at the northern site and 27.4°C in the southern site compared to 24.4°C and 25.0°C in 2021 respectively. As expected, bottom temperature at the northern and southern sites were always lower than the surface but followed the same seasonal fluctuations. Maximum recorded temperature on the bottom was higher at the northern site (26.0°C) than the southern site (23.5°C). Even while water temperatures were in the "Excellent" range for most of the season, because warm waters promote cyanobacteria activity, Coes Reservoir was rated "Fair" for the season for temperature.

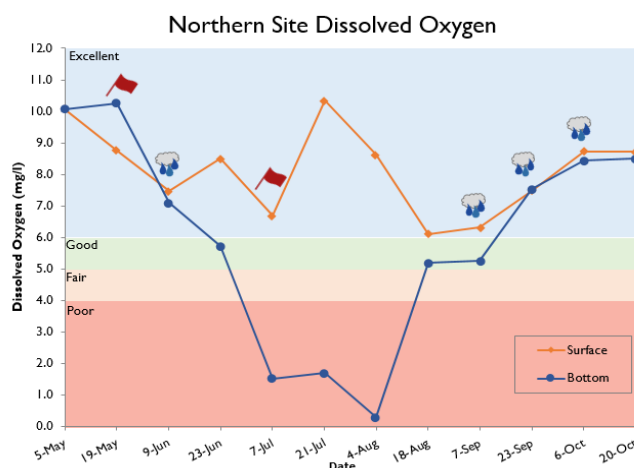
**Figure 6** - Dissolved oxygen at the surface was categorized as "Excellent" throughout the season. Bottom dissolved oxygen was considered "Good" to "Excellent" except for dates from 7-Jul through 4-Aug.

**Dissolved Oxygen at Coes Reservoir** Surface DO at the in-lake sites was above 6 mg/l, or in the range considered "Excellent", in all but one instance (see Figures 6 and 7). Other than one low outlier reading on 7-Sep (4.6 mg/l), surface DO ranged between 6.1 and 11.1 mg/l and followed a similar pattern throughout the season at the northern and southern sites. DO was highest at both sites on 21-Jul, when the lake was experiencing cyanobacteria bloom conditions. As observed in past years, the bottom of the lake experienced anoxia, or no-oxygen conditions, during the middle of the season. To better understand the extent to which oxygen depletion occurred in the water column, monthly depth profiles were taken. These included DO readings at the water's surface and at 5 ft increments until the bottom was reached. On 7-Jul and 4-Aug, while there was a healthy concentration of DO at 5 feet. However, between 5 and 10 feet, DO dropped to anoxic conditions, suggesting that the extent of the anoxia was greater than just near the bottom of the lake, which was what had been understood previously. Because of this, Coes Reservoir received a rating of "Fair" for DO in 2022.

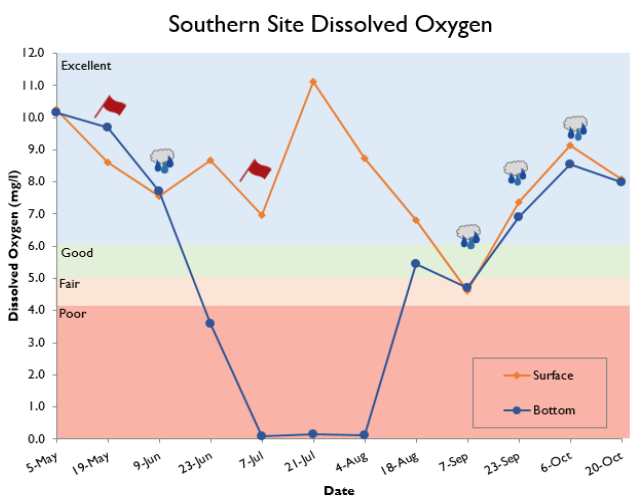
**Figure 7** - Dissolved oxygen at the surface was categorized as "Excellent" for almost every day of the season. Bottom dissolved oxygen ranged from the "Excellent" to "Poor" categories, with anoxic conditions in the middle of the season.

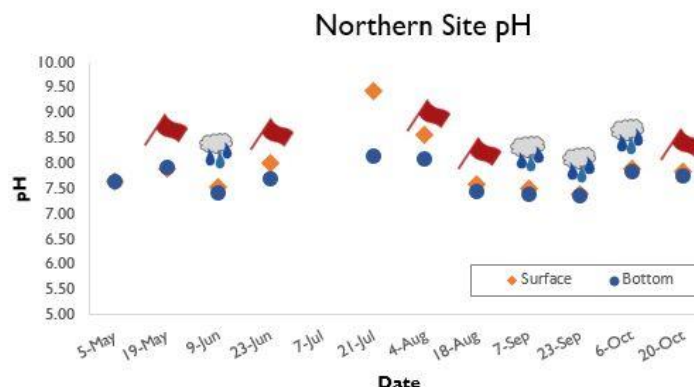
**Figure 8** - North Site: pH ranged from 7.4-9.5 at the surface and 7.4-8.2 at the bottom.

**pH at Coes Reservoir.** Surface pH at the in-lake sites ranged between 7.2 and 9.5 over the course of the season (See *Figures 8 and 9*). The highest recorded pH at the reservoir was recorded on 21-Jul when the lake was experiencing cyanobacteria bloom conditions. pH readings at the bottom at each site had a smaller range, from 7.2 to 8.2, with no discernable pattern throughout the season. pH at Coes is higher than ideal, but while the range of pH throughout the reservoir was large, pH did seem to change gradually throughout the season.

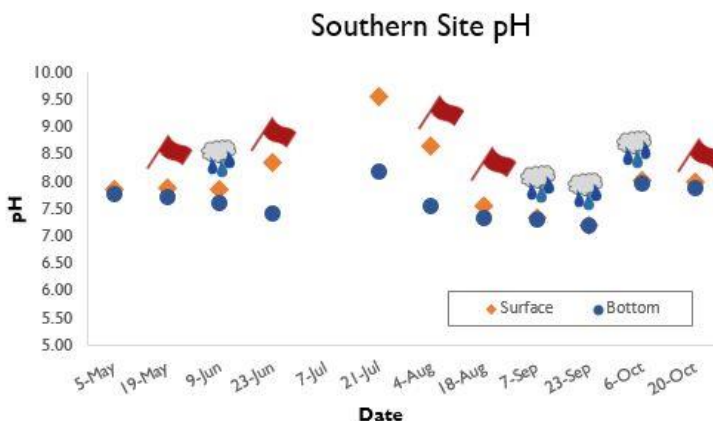
**Figure 9** - South Site: pH ranged from 7.2-9.5 at the surface and 7.2-8.2 at the bottom.

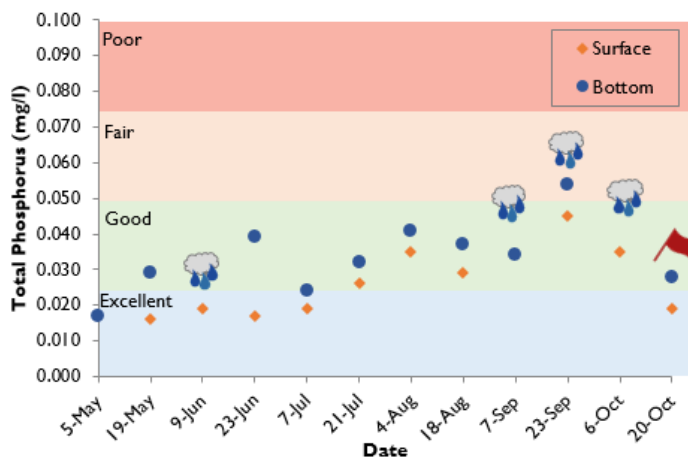
**Figure 11** - Overall total phosphorus was considered “Good” for most of the season. Surface total phosphorus was considered “Excellent” at the beginning of the season. Bottom total phosphorus reached the “Fair” category on one day.

**Nutrients at Coes Reservoir.** At the in-lake sites, TP on the surface ranged from 0.016 to 0.048 mg/l, or in the ranges considered “Excellent” and “Good”, however most results were in the latter category (see Figures 10 and 11). Recorded surface TP generally increased in concentration over the course of the season at both sites with the highest results on 23-Sep, a wet weather day. These results followed trends of past years, with an increase of nutrients over the course of the season. Bottom TP concentrations were always higher than surface TP and ranged from 0.017 to 0.054 mg/l, generally increasing as the season went on. Samples were also collected for TDP at the bottom in the northern and southern sites. Results were consistently low, either below the laboratory reporting limit or below 0.025 mg/l, the range considered “Excellent”. While L&P rated phosphorus as “Good” in 2022, it is possible that Coes Reservoir is susceptible to cyanobacteria blooms at lower phosphorus concentrations.

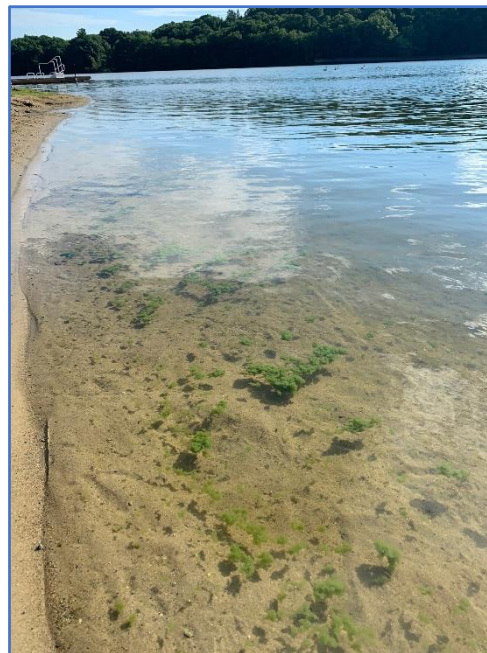
**Figure 13** – Cyanobacteria scums seen along the beach at Coes Reservoir in early July of 2022.

of copper sulfate was applied to the reservoir, which was successful in bringing the cyanobacteria density down for some time. A bloom in mid-September also occurred, but L&P did not respond with a treatment as it was outside of the recreational swimming season and it was expected that decreasing temperatures would cause the bloom to end quickly.

**Cyanobacteria at Coes Reservoir.** Exceedances of the recreational threshold, as well as the appearance of scums at the beach, caused Coes Reservoir to have multiple advisories over the 2022 season. Usually at Coes Reservoir, if there are cyanobacteria blooms, they occur in the fall. However, in early July of 2022, scums seen around the shoreline triggered a proactive closure of the waterway (see *Figure 13*). The Lakes and Ponds Program worked to simultaneously procure treatment and order testing. The delay on test results meant that the exceedance of the recreational threshold was not known until after the treatment took place. Previous to the observation of scums, cyanobacteria cell counts remained characteristically low for the early season at Coes Reservoir, below 10,000 cells/ml (see *Figure 14*). However, between 12-Jul and 20-Jul, cell counts jumped from about 48,000 to 141,000 cells/ml, before returning to safe concentrations after the treatment.

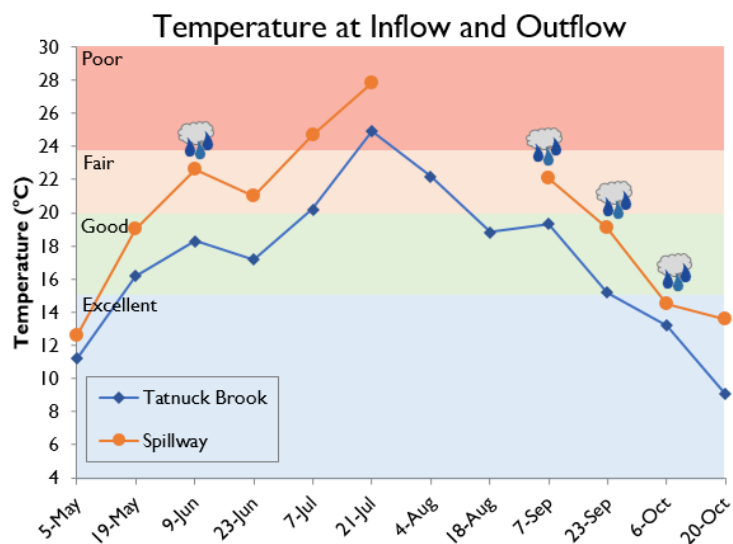
**Figure 16** – Tatnuck Brook had increasing temperatures throughout the season until mid-July, when it reached the “Poor” category, before coming back down. Temperature at the Spillway was consistently higher.

Water temperature in Tatnuck Brook was warmer than ideal (see Figure 16). Most temperature readings were above 15°C, and during the warmest parts of summer the brook entered the “Fair” and “Poor” categories for temperature. The temperature at the lake outlet was on average 2.5°C higher than in Tatnuck Brook, demonstrating how much the brook warms after passing through Coes Reservoir.

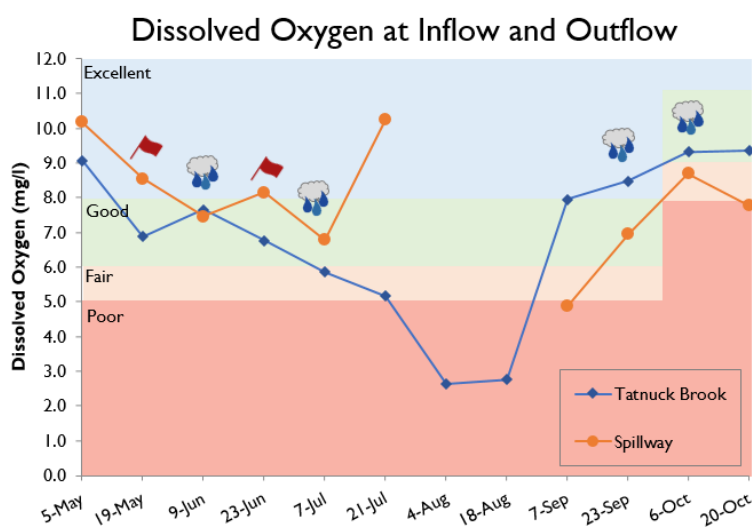
**Figure 17** – Tatnuck Brook had decreasing DO throughout the season until the end of August, when it was considered “Poor”. DO was higher at the spillway, but still was lower than ideal for a CFR.

DO in Tatnuck Brook ranged between 2.6 and 9.3 mg/l, with the lowest readings occurring when water was low during the summer months (see Figure 17). This is lower than ideal for a CFR, and could have detrimental effects on fish populations. DO was higher at the spillway, but still entered the “Fair” and “Poor” categories at the end of the season.

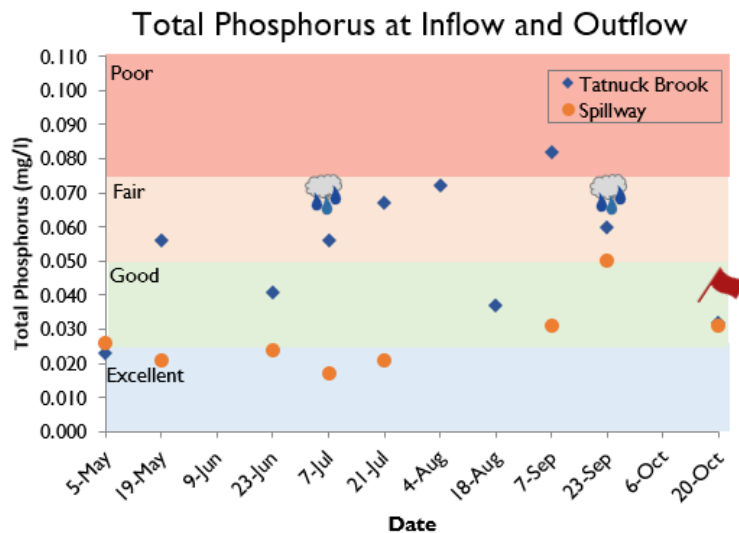
**Figure 18** - Total phosphorus was elevated in Tatnuck Brook, most sample dates were in the “Fair” category. Total phosphorus measured at the spillway was considered “Excellent” to “Good”.

TP results in Tatnuck Brook ranged between 0.023 and 0.082 mg/l, although most results were between 0.050 mg/l and 0.075 mg/l or in the range considered, “Fair” (see *Figure 18*). These high results were occurring even on days that were not considered wet weather. At the outflow, results were consistently lower, ranging between 0.017 and 0.050 mg/l, falling into the “Good” and “Excellent” categories, similar to the results at the southern site.

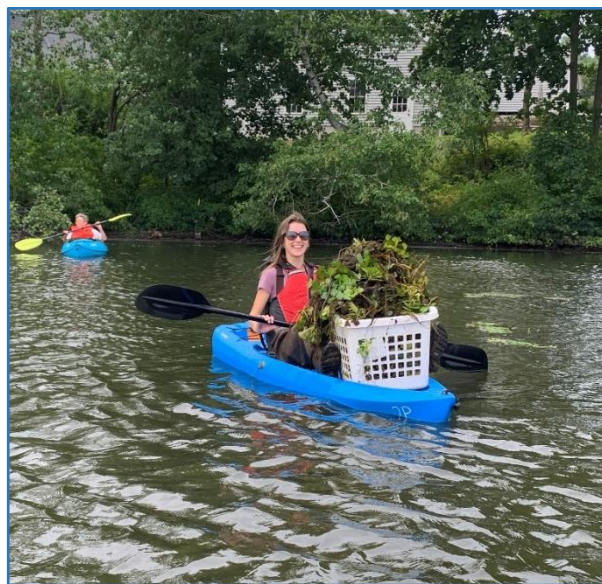
**Figure 19** – Community members participated in a Water Chestnut hand pulling event in August of 2022, clearing plants remaining in the Southern portion of the lake after herbicide treatments.

***Invasive Aquatic Plants and Animals at Coes Reservoir.*** Coes Reservoir is managed for three invasive aquatic plants: Water Chestnut (*Trapa natans*), Fanwort (*Cabomba caroliniana*), and Eurasian Milfoil (*Microphyllum spicatum*). Before the utilization of chemical treatments, the Milfoil and the Water Chestnut threatened to overtake the entire reservoir. To address populations of these plants, the Lakes and Ponds Program uses a combination of physical removal and herbicide strategies. A successful systemic herbicide treatment of Fluoridone (trade name: Sonar) took place in 2019 and significantly reduced the fanwort and milfoil density through the present. In 2022, the focus was on continuing to eradicate the Water Chestnut. Imazamox (trade name: Clearcast) was applied to the norther portion of the lake on 29-Jun and 24-Aug of 2022. To address Water Chestnut plants that were not covered by herbicide treatment, a community hand pulling event was organized in mid-August (see *Figure 19*), in which 15 community members collected plants and trash in kayaks over the course of a morning. Together, these activities were successful in reducing the density of the invasive plant during the season. Unfortunately, due to its unique reproductive strategy, it will be many more years before the water chestnut will be completely eradicated.

A plant survey conducted in September of 2022 indicated Water Chestnut as the only invasive species, among a number of native aquatic plants. The survey showed the range of Water Chestnut to be generally limited to the northern end of the lake. Although it is likely that remnant populations of fanwort and Eurasian Milfoil exist, populations were small enough to evade detection by the survey.

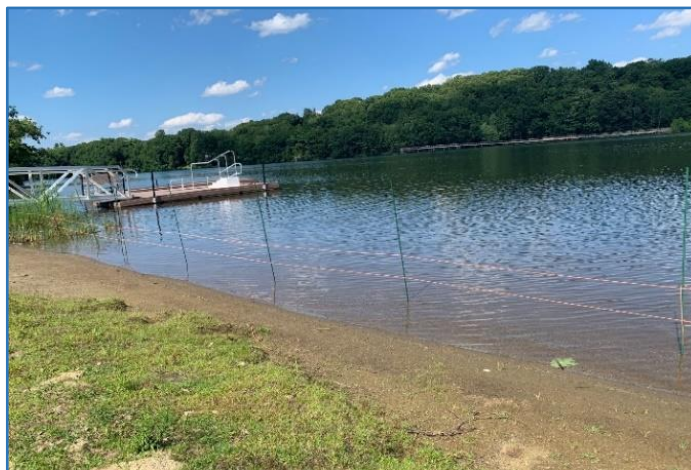
**Figure 21** – Goose fencing at Coes Reservoir was successful in deterring geese from the beach area.

In 2021, the Lakes and Ponds Program implemented a Goose Fencing Pilot Project that aimed to reduce the number of beach closures at Indian Lake and Coes reservoir due to fecal bacteria exceedances by humanely keeping geese away from the beach (see Figure 21). Geese usually enter the beach from the water and are not good at getting over low fences. They are uncomfortable when there are barriers between the beach and the water because the water is their escape route from land predators. After erecting a small fence between the shore and

water during the evening hours, L&P found the use of the beach by the geese was significantly reduced, and beach closures due to *E. coli* also seemed to be reduced. In 2022, the Lakes and Ponds Program improved the construction of the fencing using higher quality materials to make installation easier to increase usage during the summer. Use of the beach by geese appeared to be reduced in 2022 and there were no beach closures due to fecal bacteria exceedances. L&P plans to continue the use of goose fencing at Coes Reservoir's beach and to develop an effective and easy to use solution to reduce goose congregation on the beaches and limit beach closures due to fecal bacteria exceedances.

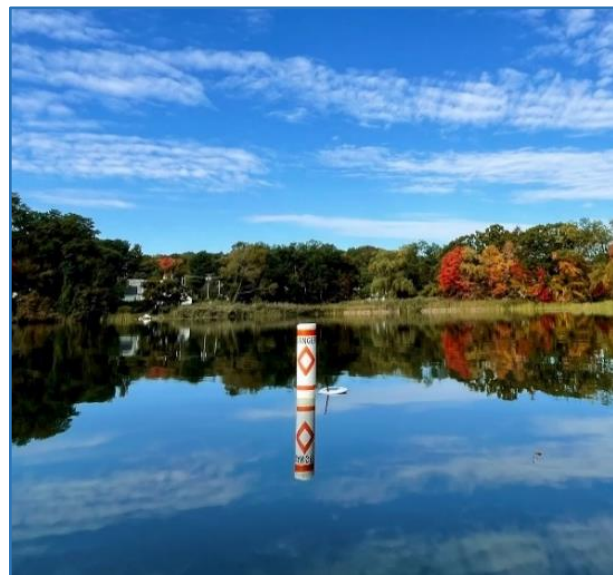
**Figure 22** – A continuous monitoring buoy will be deployed at Coes Reservoir in 2023 to collect parameters associated with cyanobacteria activity.

As Coes Reservoir experienced impacts from cyanobacteria in 2022, the Lakes and Ponds Program will continue to refine its monitoring and management approach to avoid prolonged lake closures. Since 2021, the Lakes and Ponds Program has utilized solar powered continuous monitoring buoys (see *Figure 22*) at Lake Quinsigamond, with a new buoy installed at Indian Lake in 2022. These buoys contain probes that track the cyanobacteria indicators phycocyanin and chlorophyll, as well as turbidity and temperature, and remotely upload them to an online database where data can be viewed in real time. The Lakes and Ponds Program intends to install a buoy at Coes Reservoir. This should allow for improved responsiveness to mobilize management activities in the case of an oncoming bloom.

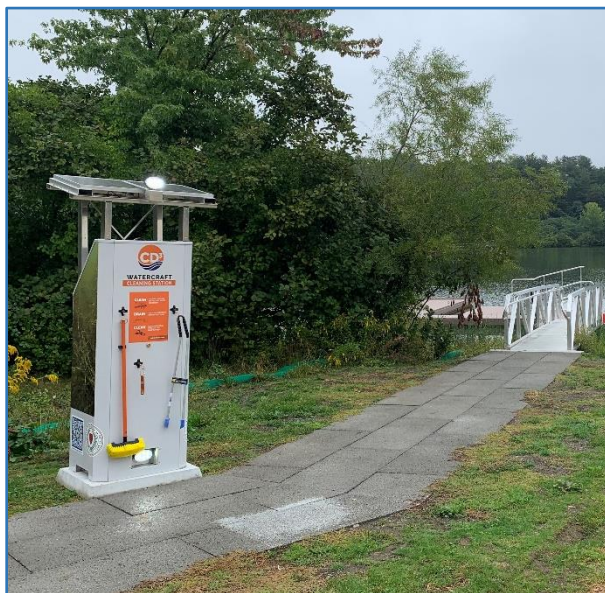
**Figure 23** - Solar powered boat decontamination stations were installed at Coes Reservoir to help enable boaters to stop invasive plants at the source by decontaminating watercraft before and after use.

**Boat Decontamination Stations.** The Lakes and Ponds Program is committed to monitoring and managing the invasive aquatic plants that can obstruct waterways. However, the best way to curb invasive aquatic plants' effect on lake ecosystems is to keep them out of the lakes in the first place. The most common way invasive aquatic plants are spread is the accidental introduction as hitchhikers on boats and trailers. In many cases, even a small piece of a plant can re-root and start growing in a waterbody. In the fall of 2021, the Lakes and Ponds Program was able to utilize funds from the American Rescue Plan Act (ARPA) to install solar powered boat decontamination stations at Indian Lake and Coes Reservoir (see *Figure 23*). These stations are free to use and contain instructions on best practices for intercepting invasive aquatic plants before they can take root in Worcester's waterbodies. There are blowers and grabbers to remove weeds in hard-to-reach places, brushes to scrub algae off the sides of boats and tools to drain and dry bilge water. To learn more about invasive aquatic plants and these decontamination stations see the recent episode of "The Blue Space Minute" on the City of Worcester YouTube Channel [Blue Space Minute - Boat Cleaning Stations - YouTube](#).
